Project acronym:	Geo-Drill		
Project title:	Development of novel and Cost-Effective drilling technology for geothermal Systems		
Activity:	LCE-07-17-Renewables		
Call:	H2020-LC-SC3-2018-RES-TwoStages		
Funding Scheme:	RIA	Grant Agreement No:	815319
WP 3	Material Testing and Characterization

D3.7 – Report on materials testing and characterization

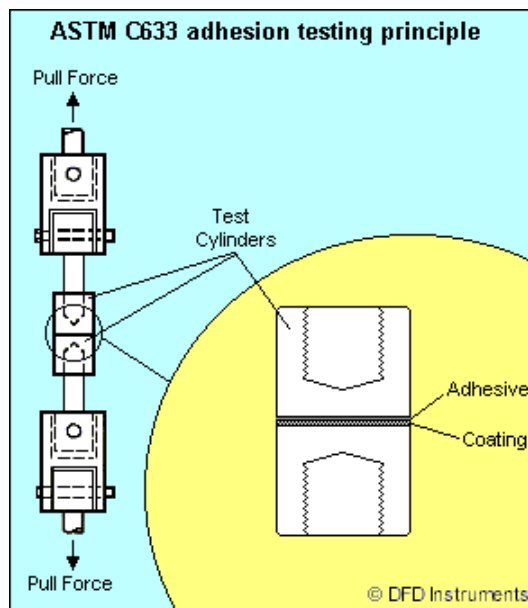
CSM/RINA performed adhesion test according to ASTM C633 to determinate the degree of adhesion to a substrate, or the cohesion strength of the coating after the application of a normal tension to the surface. The test consists of coating one face of a substrate fixture, adhesive bonding this coating to the face of a loading fixture, and subjecting this assembly to a tensile load normal to the plane of the coating using a tensile testing machine, Figure 2.1.1. Failure stress is calculated dividing the maximum load by the cross-sectional area of the specimen. Fractured surfaces are examined to determine the location of the failure in the specimen.

Figure 2.1.1 Standard ASTM C633 adhesion testing principle

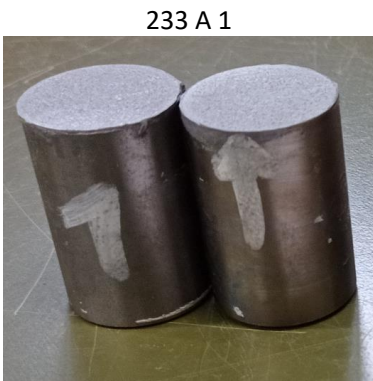
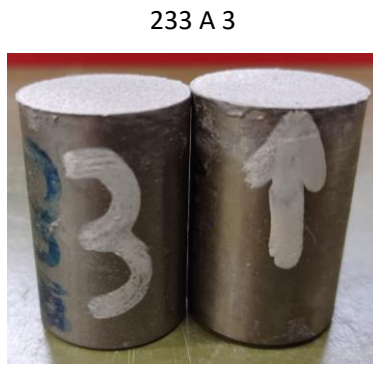
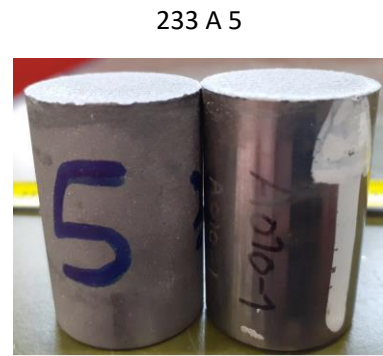
Figure 2.1.3 - 233 A Samples after pull test

Glue failure

Figure 2.1.3 to Figure 2.1.14 show tested samples and comments about failure modes. The results of pull tests are summarized in Table 2.1.3.

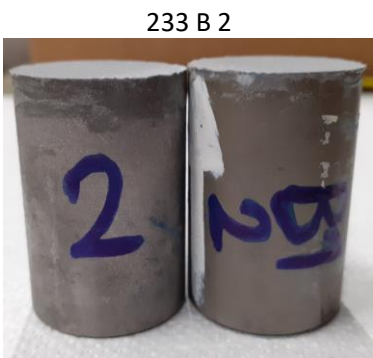
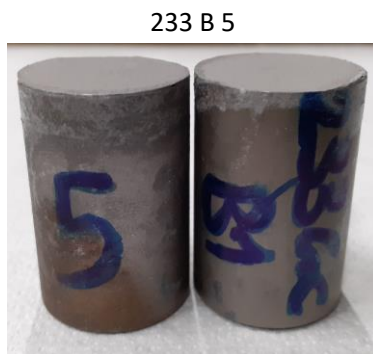
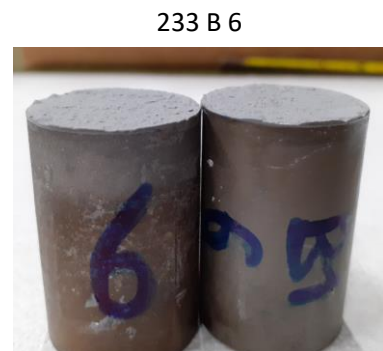
Figure 2.1.4 - 233 B Samples after pull test

Glue failure

Coating cohesion failure

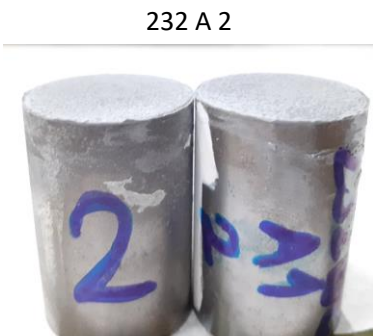
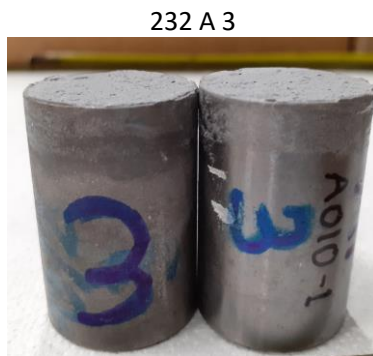
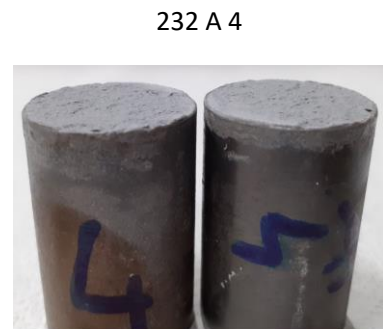
Figure 2.1.5 - 232 A Samples after pull test

Glue failure

Coating cohesion failure

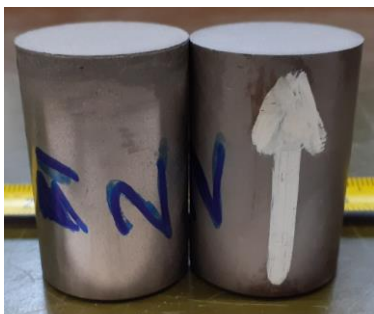
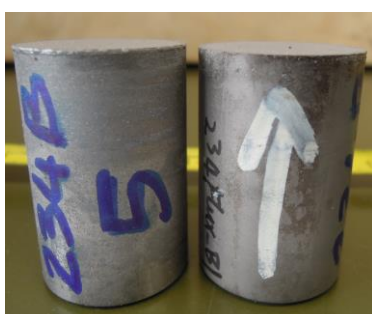
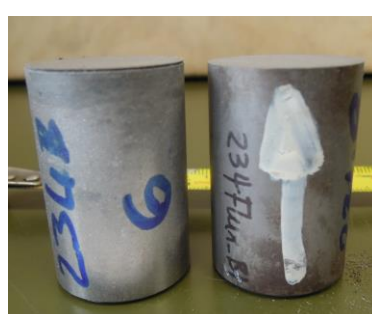
Figure 2.1.8 - 234 B Samples after pull test

Coating adhesion failure

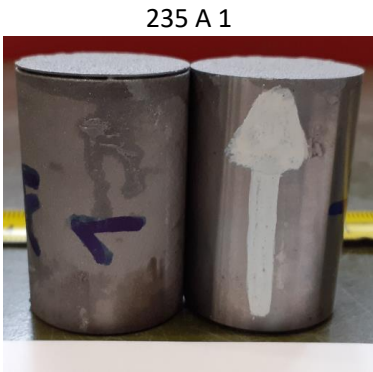
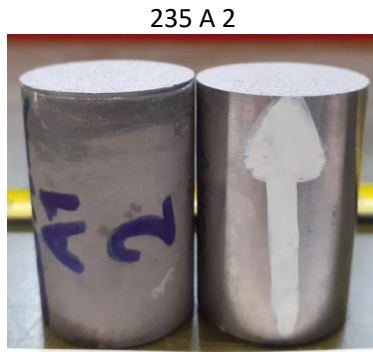
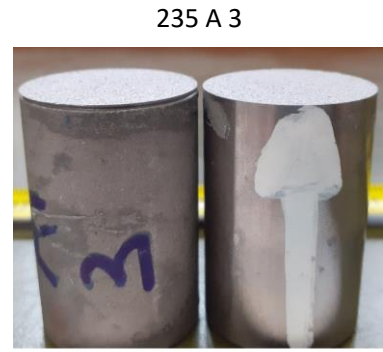
Figure 2.1.9 - 235 A Samples after pull test

Coating adhesion failure

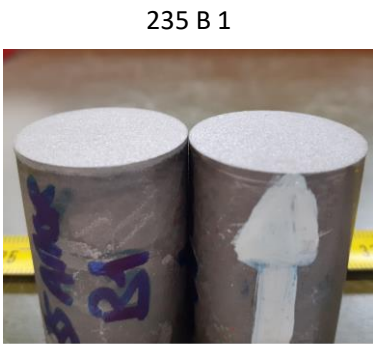
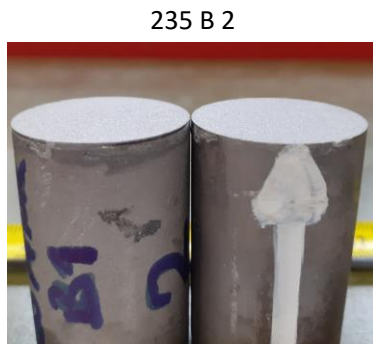
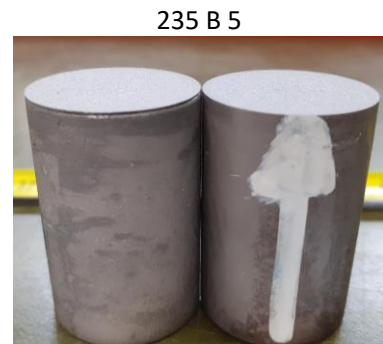
Figure 2.1.10 - 235 B Samples after pull test

Coating adhesion failure

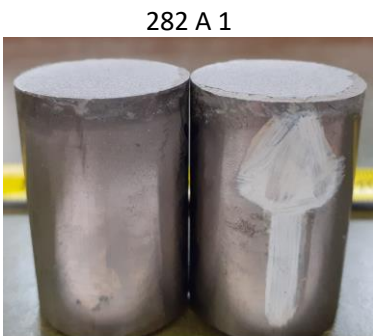
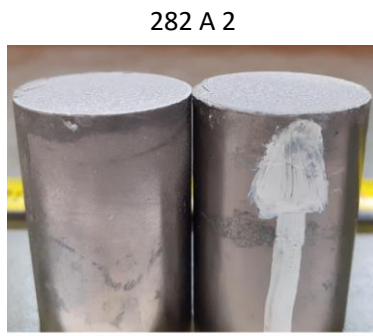
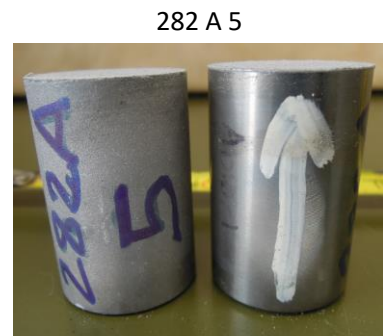
Figure 2.1.11 - 282 A Samples after pull test

Dual failure mechanism due to both the adhesion of the coating and the failure of the glue

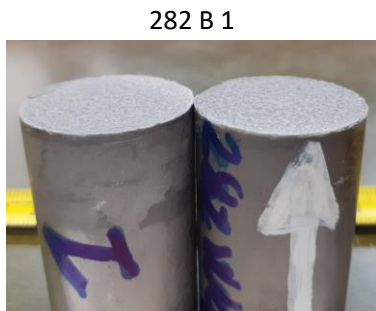
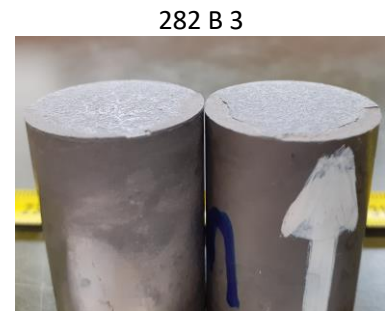
Figure 2.1.12 - 282 B Samples after pull test

Dual failure mechanism due to both the adhesion of the coating and the failure of the glue

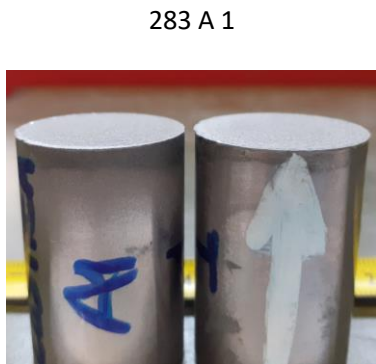
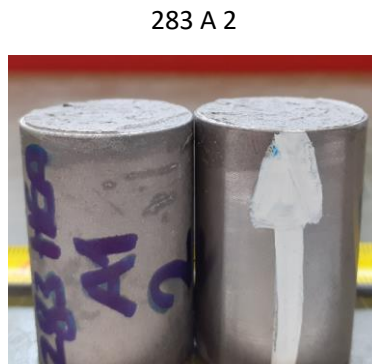
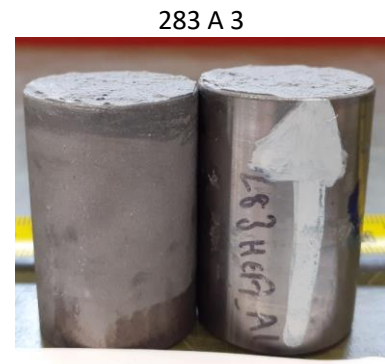
Figure 2.1.13 - 283 A Samples after pull test

Coating cohesion failure

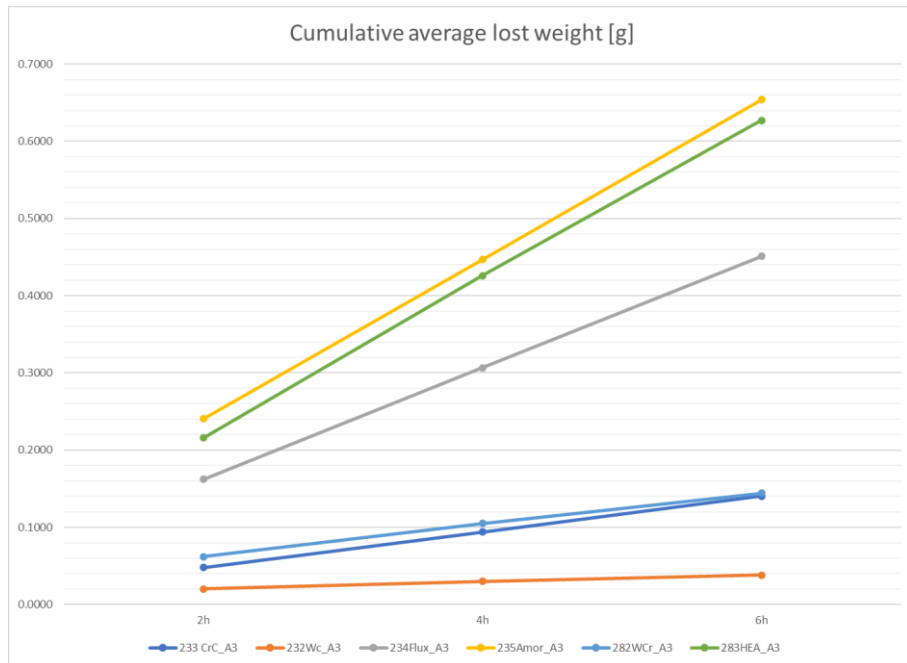
Figure 2.1.22 shows the cumulative average weight loss for every sample. Table 2.1.7 contains weight loss value for every 2h test step and a representative picture of the wear occurred to the samples.

Figure 2.1.22 - Cumulative average weight loss [g] vs test time [h]

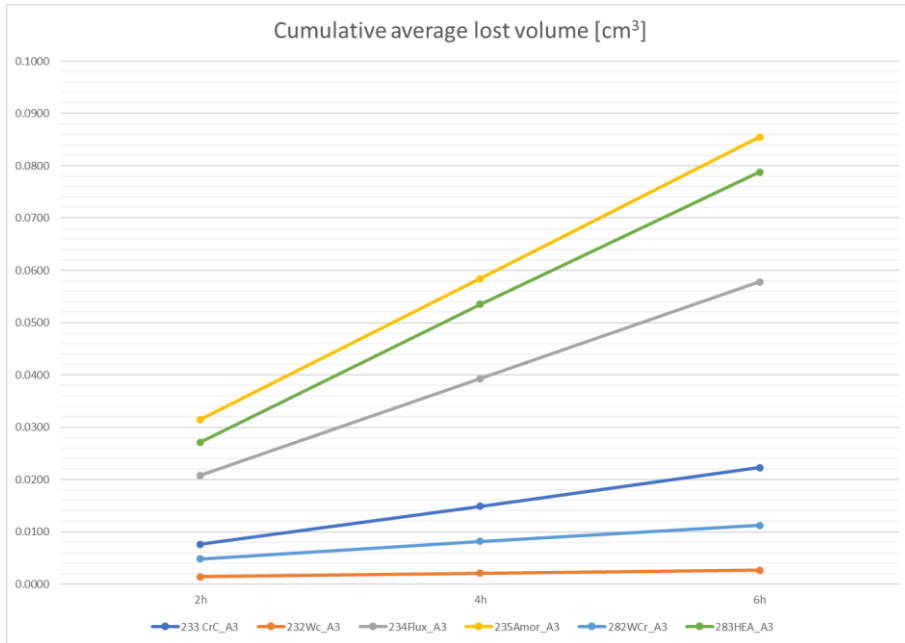
Figure 2.1.23 shows the cumulative average lost volume for every sample. Table 2.1.9 contains volume loss values for every 2h test step and a representative picture of the wear occurred to the samples.

Figure 2.1.24 - Cumulative average lost volume [cm³] vs test time [h]

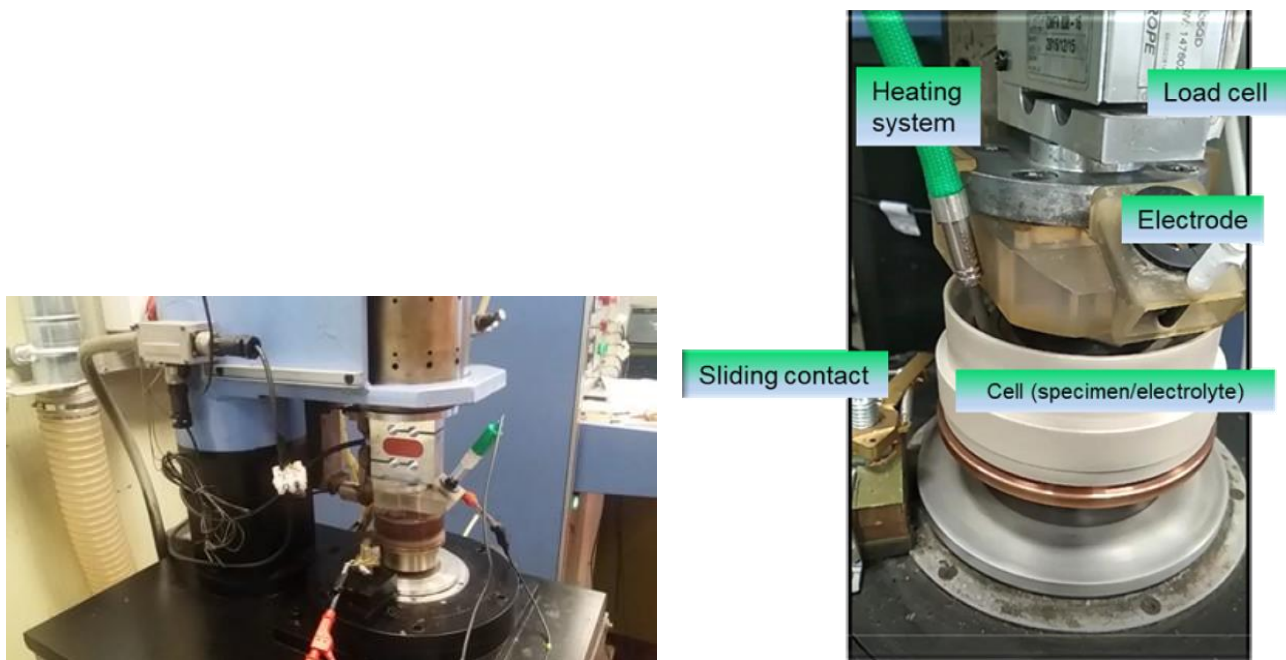
In the cell, the reference electrode is a saturated calomel (SCE) while the counter electrode is a Pt wire. The modified RTM ball-on-disk tribometer overview, and some details of the cell are shown in the two pictures reported in Figure 2.1.49.

Figure 2.1.49 - The modified RTM ball-on-disk tribometer (left) with the electrochemical cell during a test. Right some details of the cell. Bottom, Xylan disk for tribocorrosion test

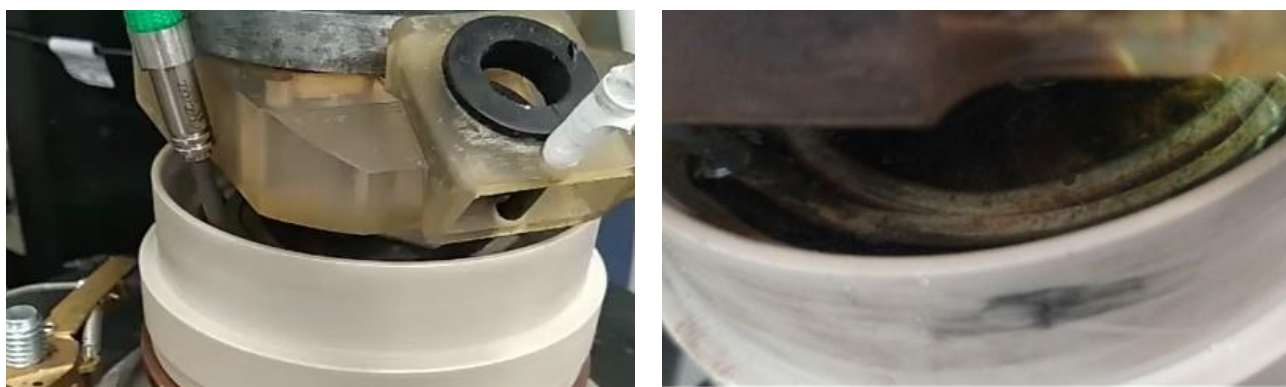
For tests above room temperature (RT) the testing apparatus is provided with a heating system to keep the solution at fixed and constant T value, by a coil that is located inside the cell, Figure 2.1.50.

Figure 2.1.50 - Detail of the heating system with the coil inside the cell

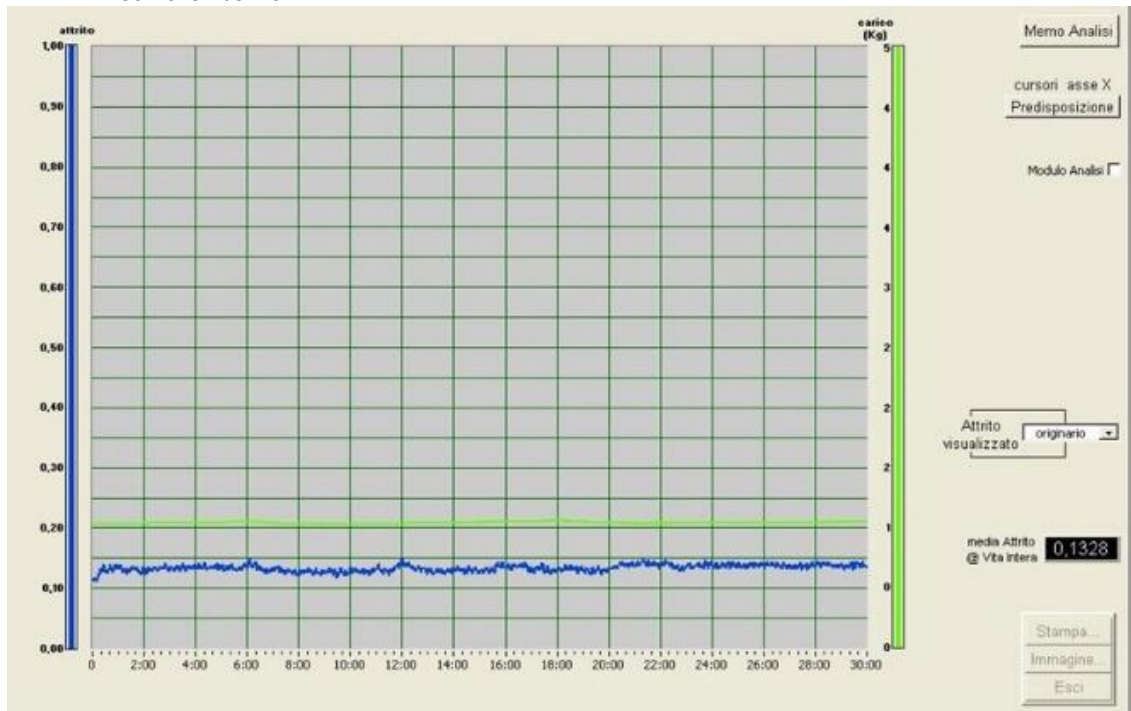
As an example, Figure 2.1.52 shows a plot of the CoF for a single step.

Figure 2.1.52 - One of the CoF plot reporting the curve for Xylan0.5wt %GO single wear step 30 min lasting (load in kg – y axis).

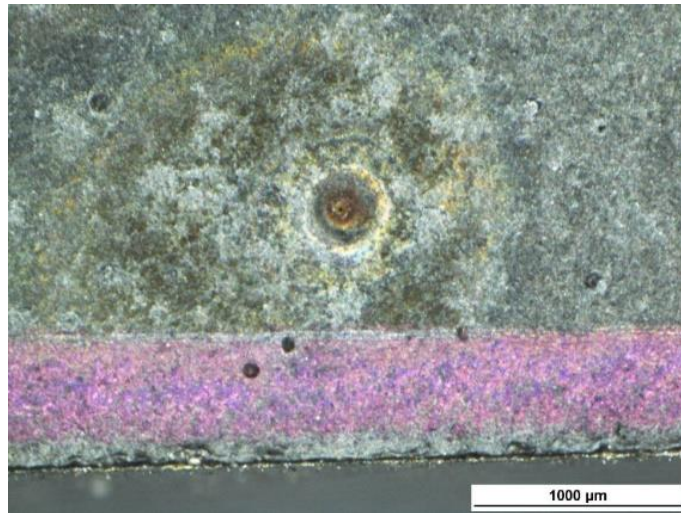
After the immersion in the heated solution the material Xylan0.5wt%GO gradually modifies its appearance with the growth of some brown spots detected by OM Figure 2.1.54:

Figure 2.1.54 - OM image of the surface of Xylan0.5wt%GO coated specimen after the tribocorrosion test in NS4 solution @80°C. Large and small pores.

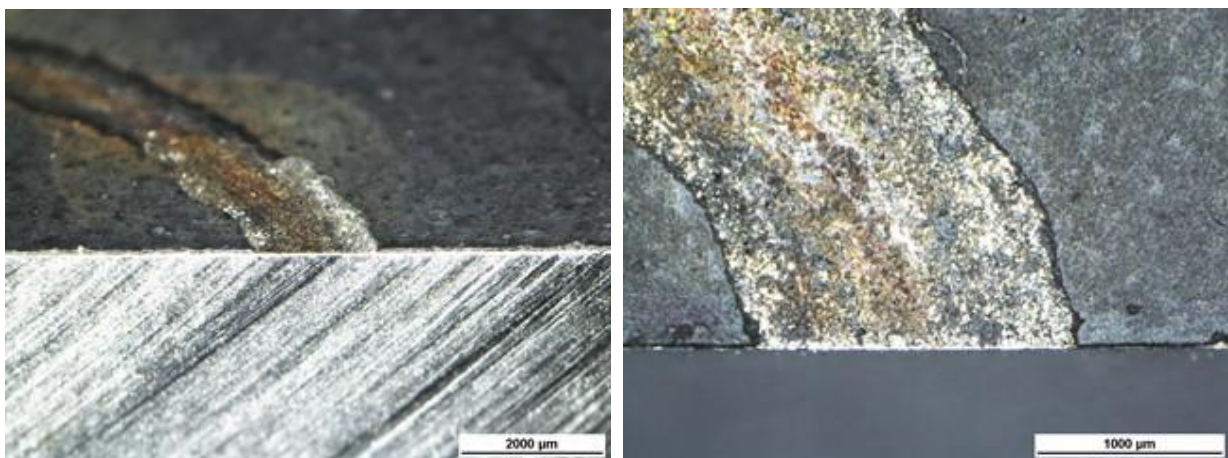
In Figure 2.1.55 the wear track of Xylan0.5wt%GO coated specimen after the 9-step tribocorrosion test.

Figure 2.1.55 - OM images of the wear track for Xylan0.5wt%GO coating after the tribocorrosion test in NS4 solution @80°C (as cross-cutted)

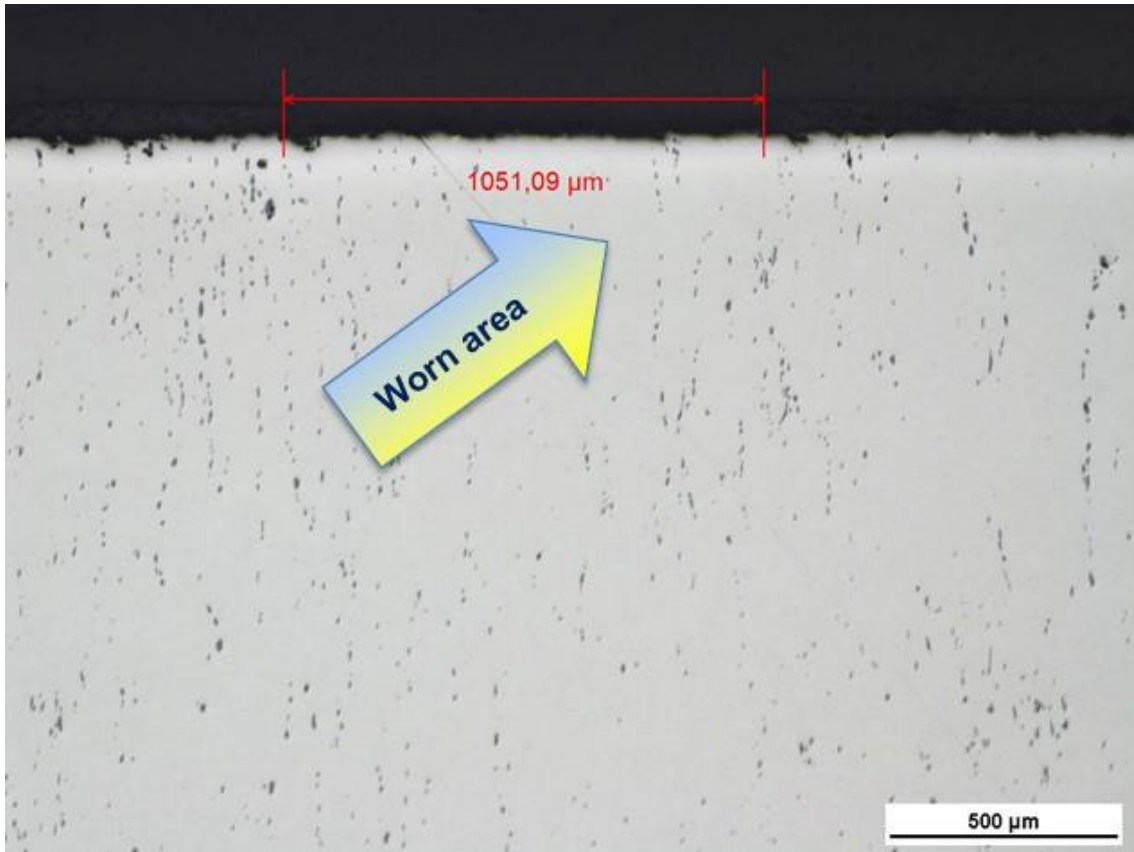
Figure 2.1.56 - OM image of the cross section for Xylan0.5wt%GO coated specimen after the tribocorrosion test in NS4 solution @80°C with the track zone identified by the arrow

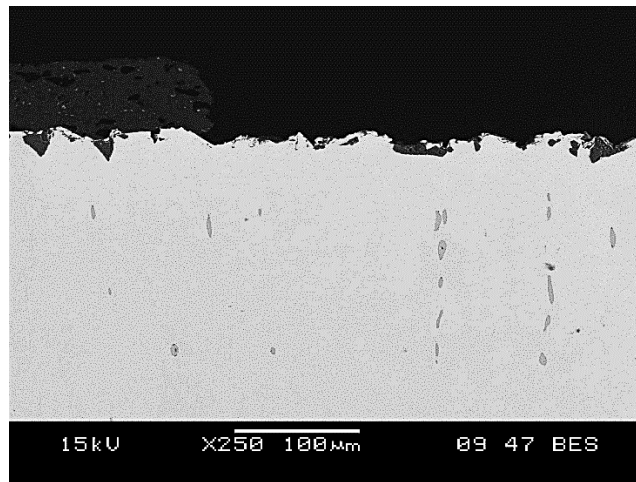
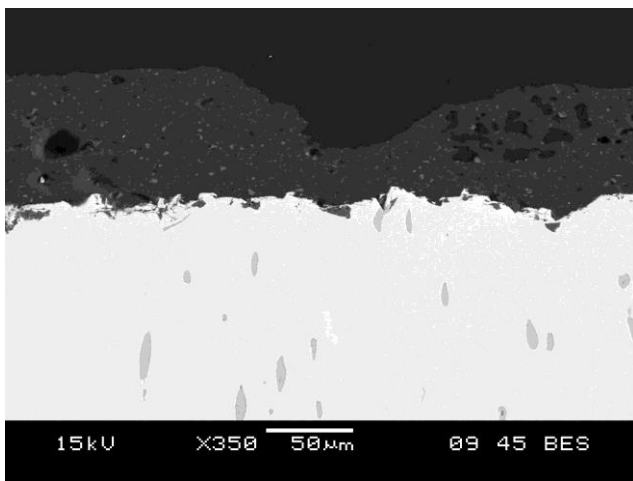
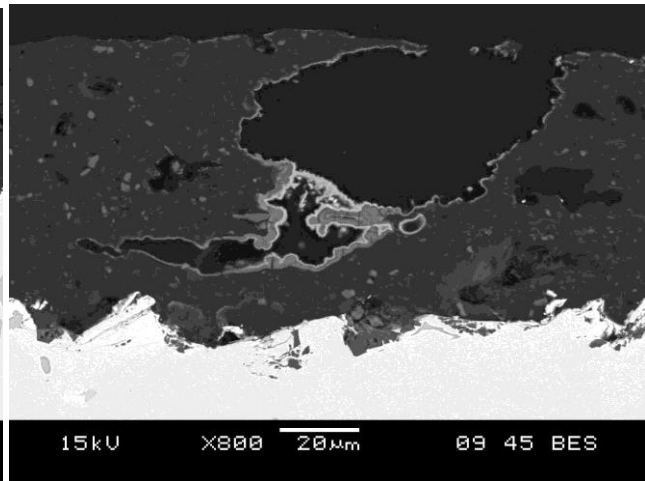
SEM investigation better evidenced the detachment of the coating that was completely removed in most of the wear track, or strongly reduced in its thickness; parts of the coating not detached show a fully porous structure with some large and deep porosities with exposed surface possibly with modified composition Figure 2.1.57:

Figure 2.1.57 - SEM micrographs of the cross section for Xylan0.5wt%GO coated specimen after the tribocorrosion test in NS4 solution @80°C. Upper images: wear track zone with the coating completely detached. Lower images: wear track zone. Large and deep porosity deposited residuals. Backscattered mode (Mag. 250X, 350X, 800X).

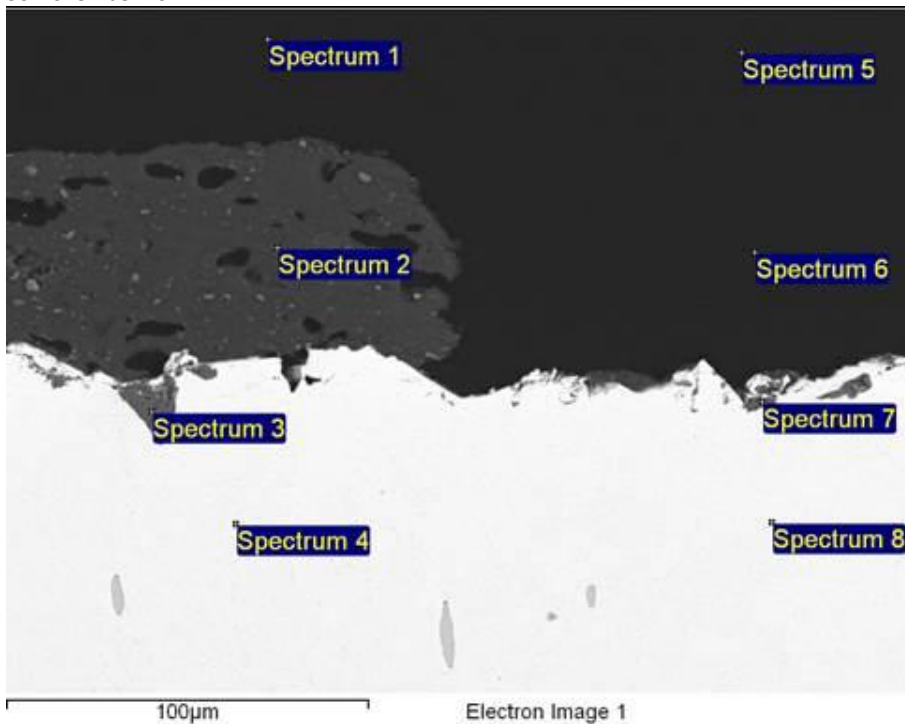
The EDS elemental analyses, Figure 2.1.58, evidenced the presence of oxides:

Spectrum	In stats.	C % wt	O % wt	Al % wt	Si % wt	Cl % wt	Cr % wt	Mn % wt	Fe % wt	Mo % wt	Total % wt
1	Yes	85.19	11.67			3.15					100.00
2	Yes	50.25			0.54					49.22	100.00
3	Yes	10.96	38.18	50.87							100.00
4	Yes	7.01	1.01				17.14		74.84		100.00
5	Yes	93.94				6.06					100.00
6	Yes	86.88	10.16			2.96					100.00
7	Yes	17.38	35.23	42.57					1.91	2.92	100.00
8	Yes	6.60	1.18				17.16	1.00	74.05		100.00

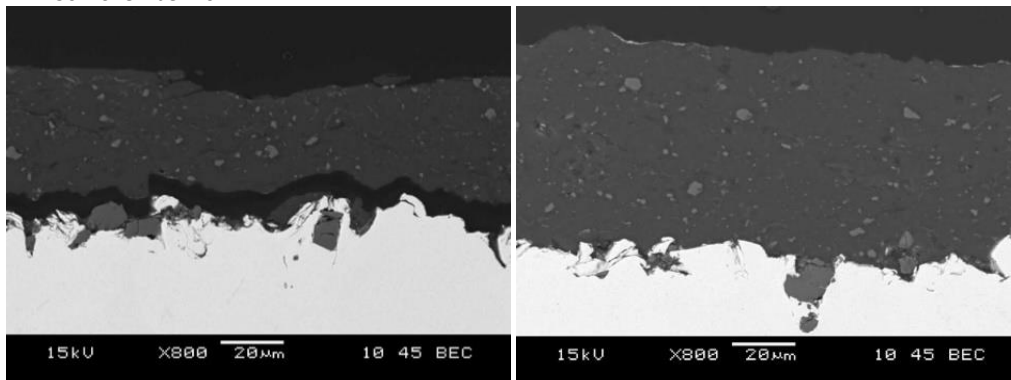
SEM images are reported in following Figure 2.1.62:

Figure 2.1.62 - SEM cross-section micrographs for Xylan0.5wt%GO coated specimen tested in NS4 @80°C at 10N load. Left: wear track zones. Right: far from the wear track. (Mag. 800X)

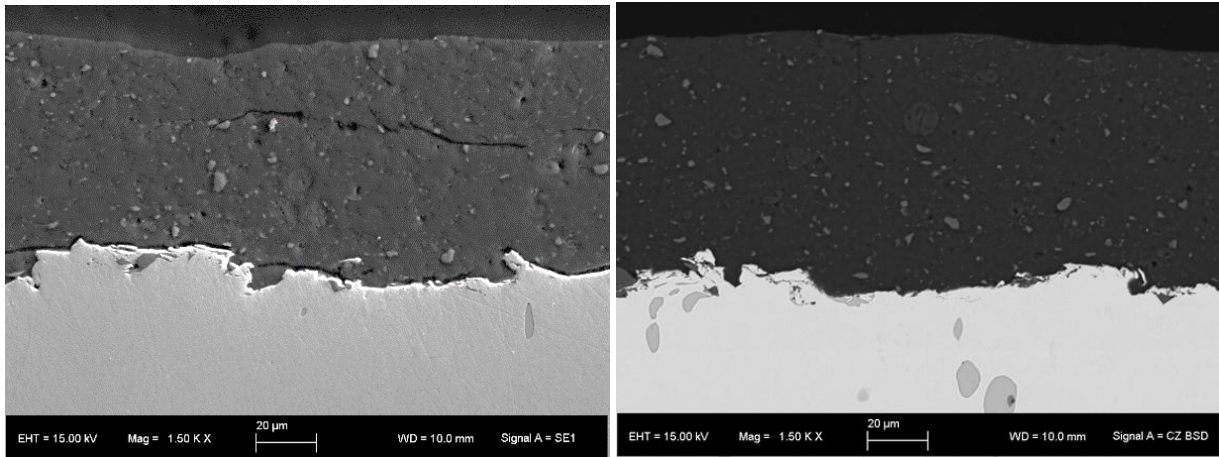
The coating looks dense as well, with no evident porosities. The EDS microanalysis is reported in Figure 2.1.63.

Figure 2.1.63 - SEM micrographs of Xylan coated specimen tested in NS4 @80°C at 10N load. Wear scar zone (left) and far from the wear track (right). Mag. 1500X

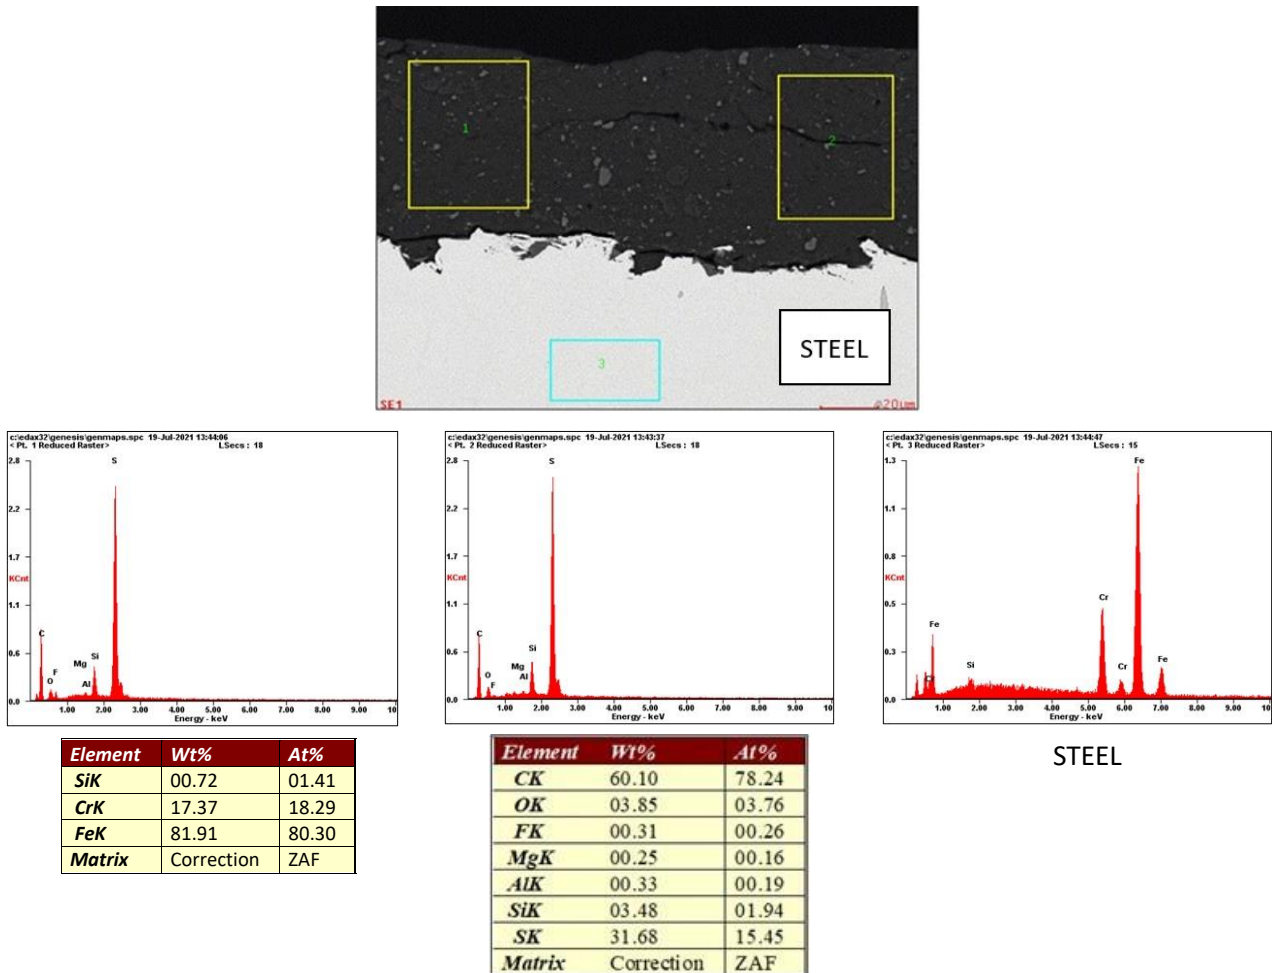
Figure 2.1.64 - EDS area microanalysis for Xylan tested in NS4 @80°C at 10N load.

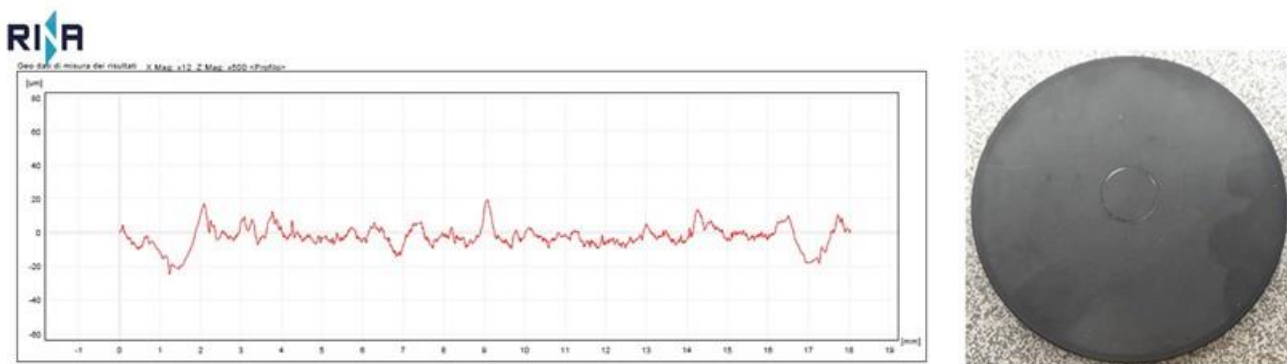
Examples of profilometry analyses are reported below, for Xylan0.5wt%GO and Xylan. For Xylan0.5wt%GO and along one diameter (several diameters were checked) the graph evidenced the two tracks, while for Xylan there was no evidence of the wear grooves as shown (Figure 2.1.65 and Figure 2.1.66) :

Figure 2.1.65 - Profilometry graph for Xylan0.5wt%GO tested in NS4 @80°C at 10N load. On the right the tested specimen

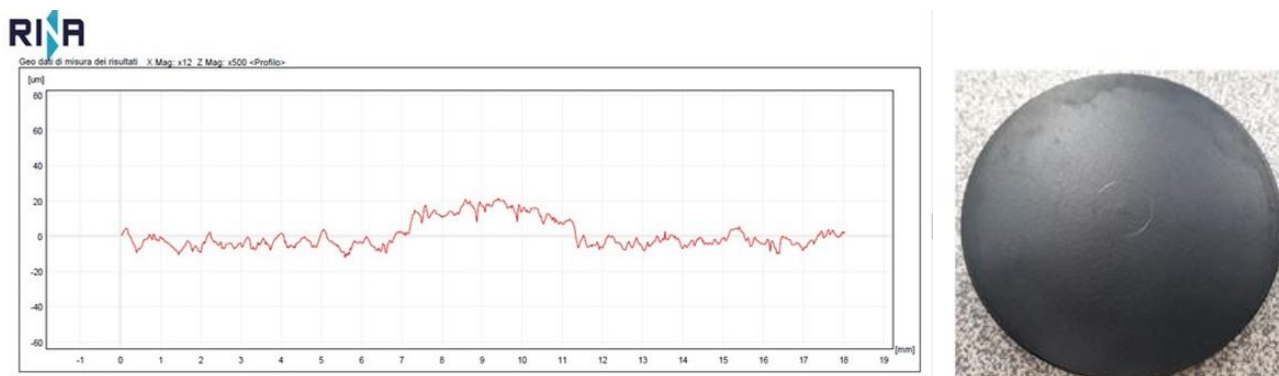
Figure 2.1.66 - Profilometry graph for Xylan tested in NS4 @80°C at 10N load. On the right the tested specimen

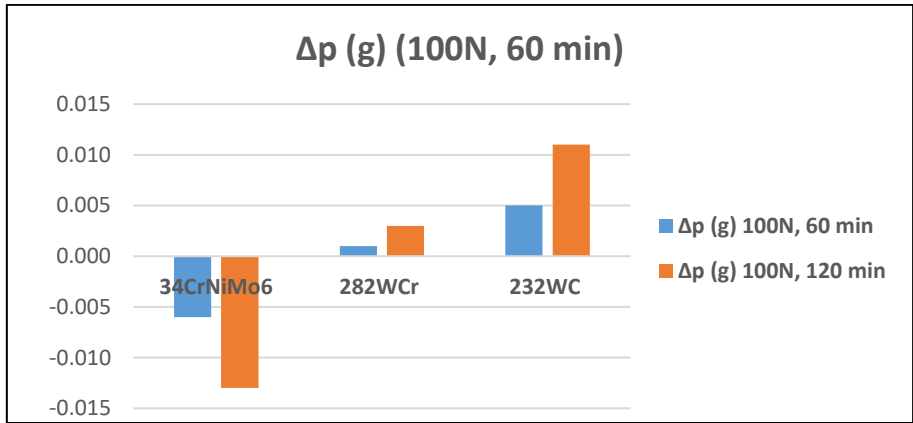
The result is confirmed after 60 min more sliding; at 120 min of testing the substrate has lost 130 mg, while the 232WC (CA3) Cermet specimen has gained 110 mg (Figure 2.1.67):

Figure 2.1.67 - The weight variation after two cycles (four step) tribo corrosion tests of 30 min duration each

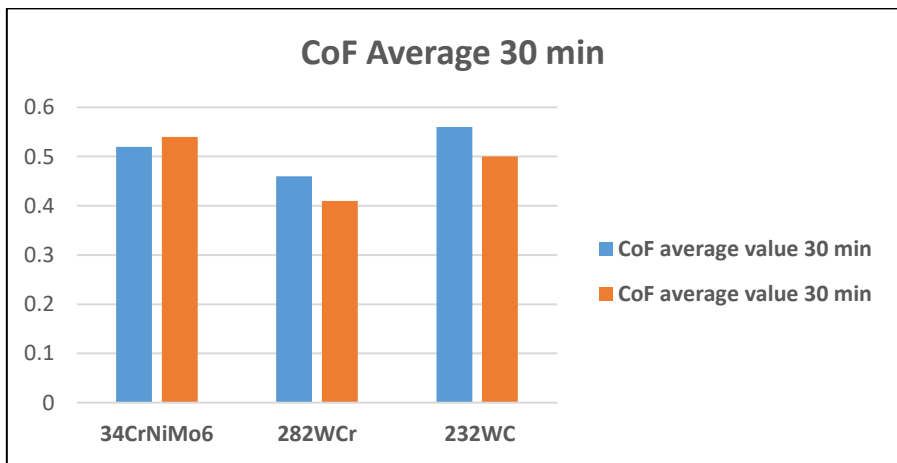
The Friction coefficient CoF average values recorded are summarized in the following Figure 2.1.68 :

Figure 2.1.68 - Average values of Friction Coefficient recorded for the tested HVOF coating materials and steel substrate

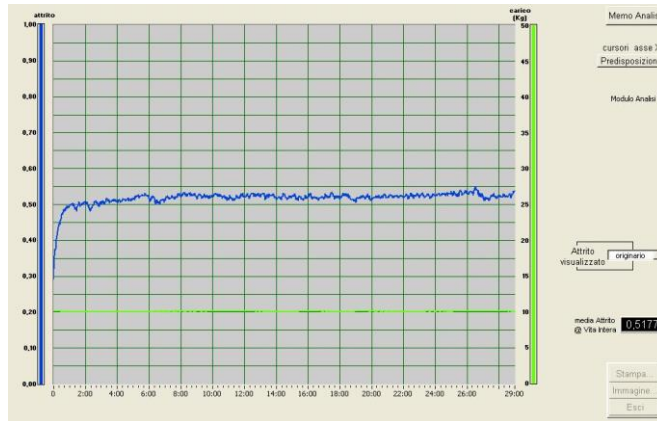
As an example, herein a CoF plot for a single step of the steel substrate (Figure 2.1.69):

Figure 2.1.69 - The CoF plot with the curve for 34CrNiMo6 steel substrate single wear step 30 min lasting. The load is in Kg

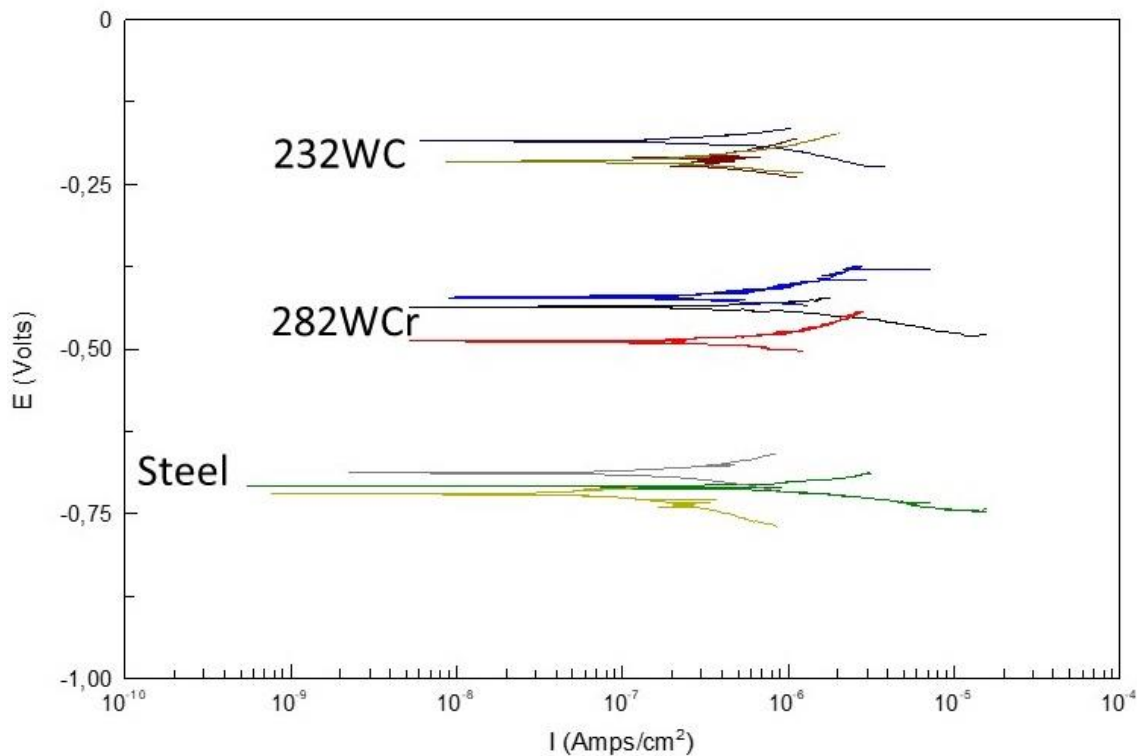
The evaluated current densities are very similar for the three classes of materials and showed a slightly higher average IO value for 282WCr. However, it was observed that the OCPs for this coating could not reach a stable value in the time interval between two wear steps.

Figure 2.1.72 - The PD curves grouped for the Steel substrate and for the 232WC and 282WCr coatings

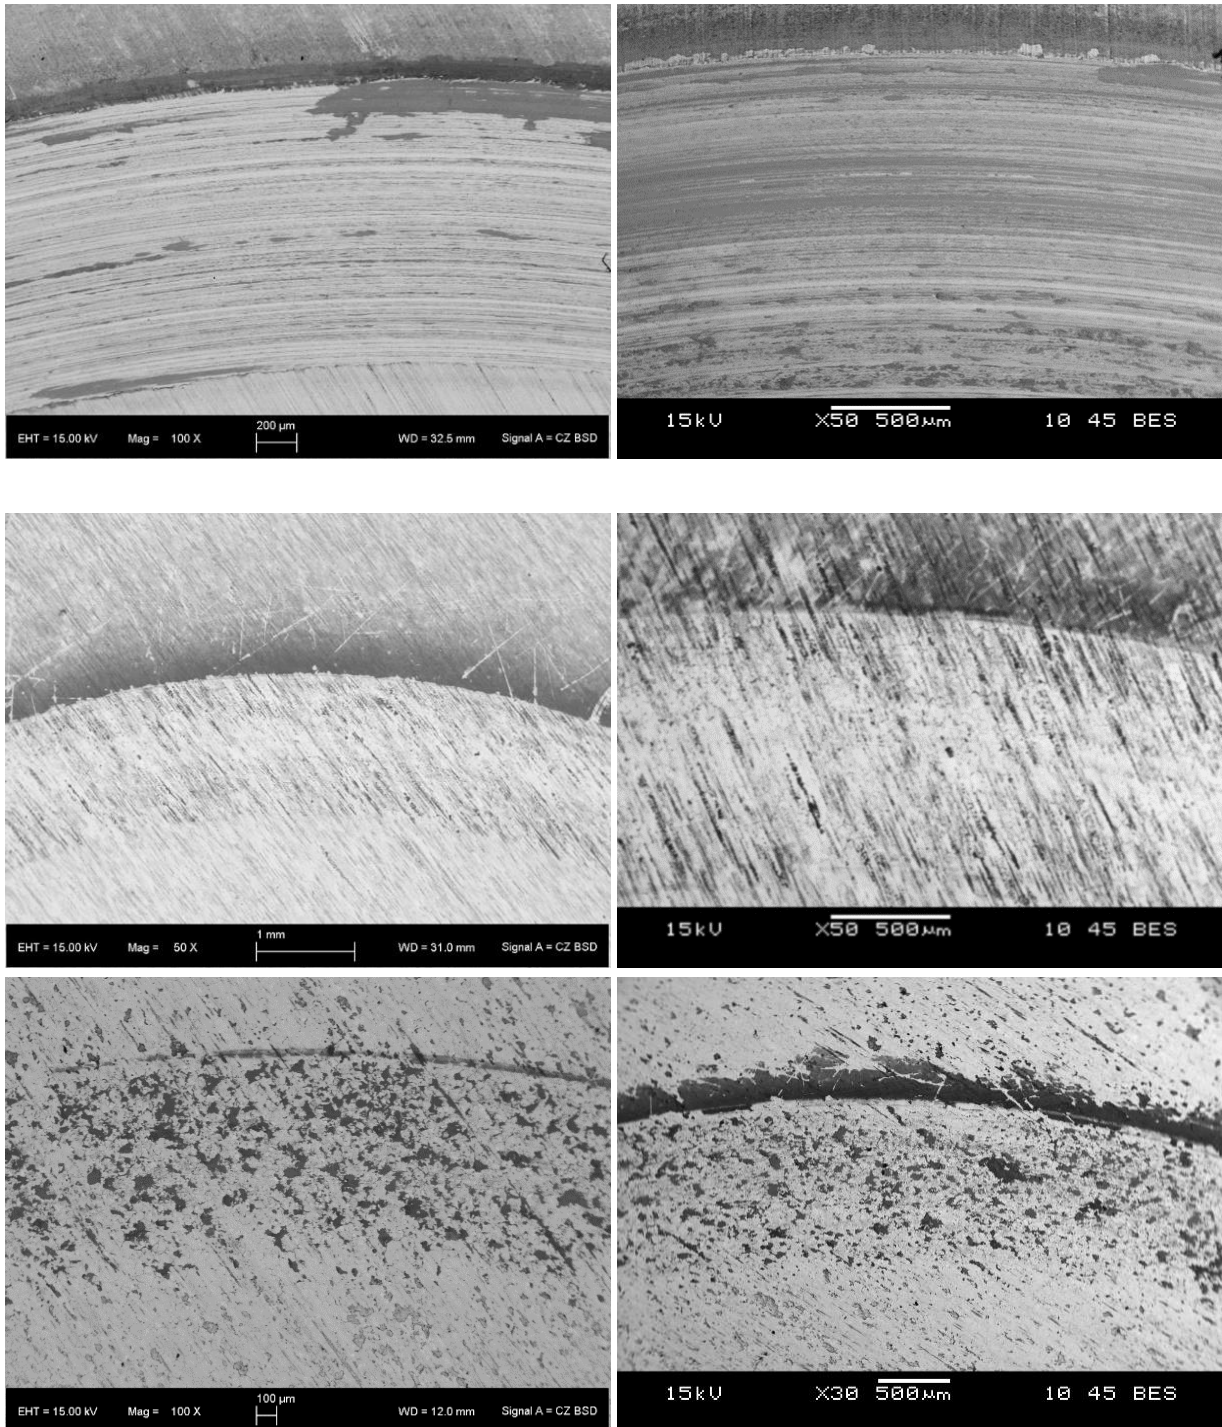
In fact, especially in the wear track area, mixed oxides containing Fe and Cr were detected, especially they seem to be in a higher amount in 282 WCr than in 232WC.

Figure 2.1.73 - SEM Micrographs of track zone for tested 34CrNiMo6 steel, 232WC (middle) and 282WC coatings (lower).

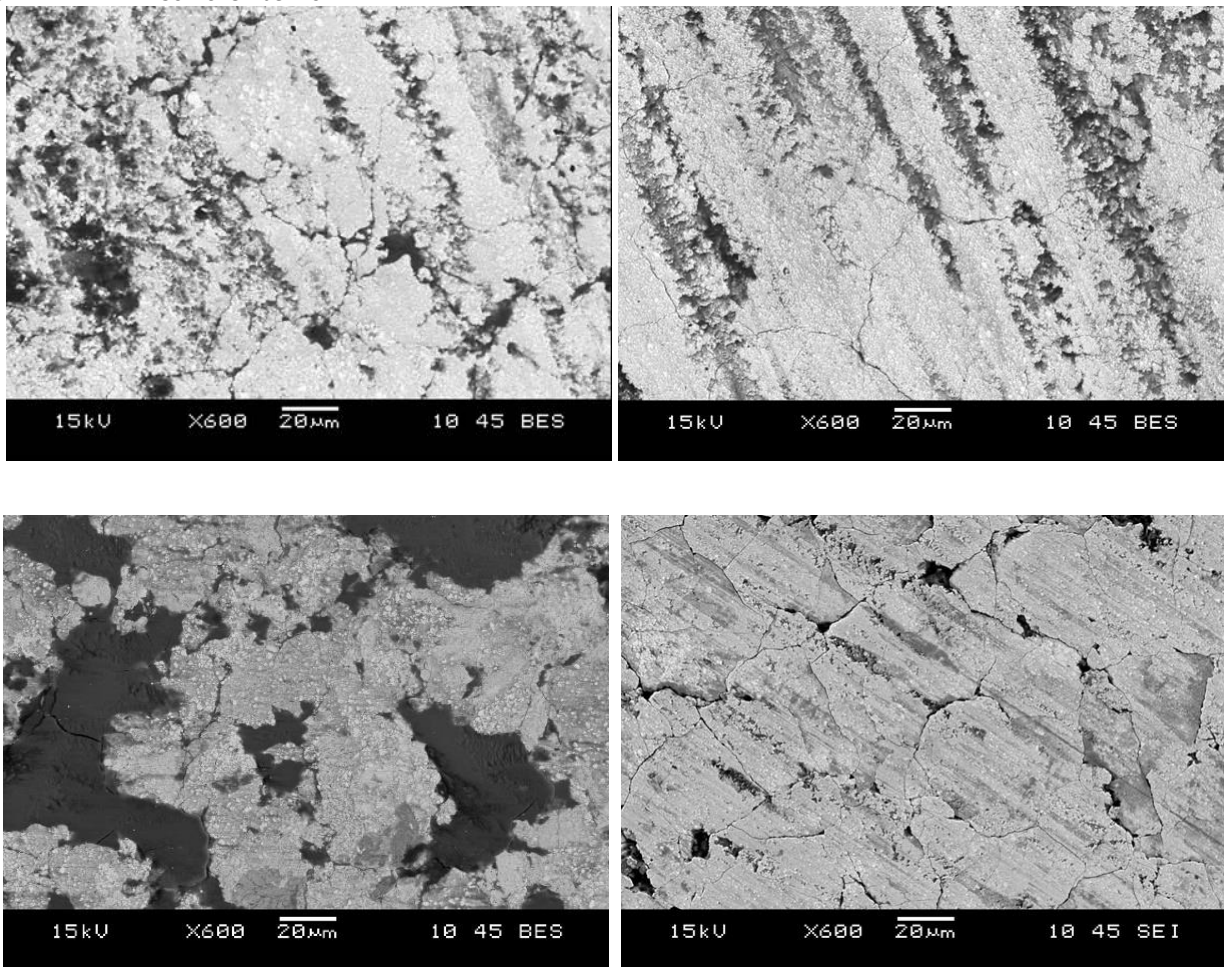
Figure 2.1.74 - SEM Micrographs of tested 232WC (upper) and 282WCr coatings (lower). Area inside the wear track (left) and outside the wear track (right)

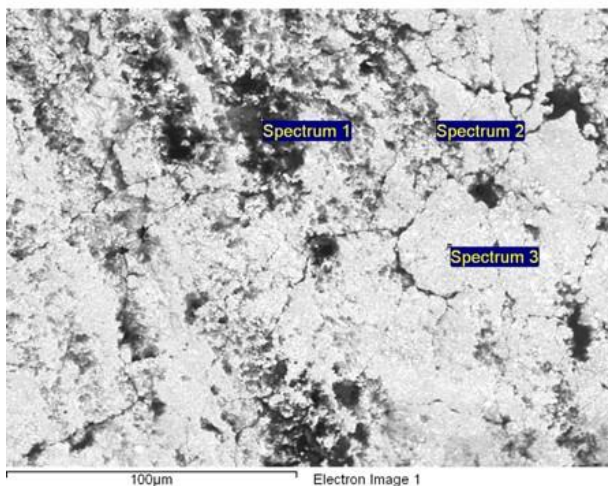
For 232WC EDS analysis reported below evidenced some iron (mixed oxides) in the wear track and outside the wear track, while other deposited material are residuals from the solution (Figure 2.1.75 and Figure 2.1.76).

Spectrum	In stats.	O	Mg	Al	Ca	Cr	Fe	Co	W	Total
1	Yes	34.37	6.16	5.02	0.62	7.29		12.97	33.57	100.00
2	Yes	23.87	4.56	1.34		4.47	4.97	13.36	47.43	100.00
3	Yes	1.88				2.31		6.39	89.41	100.00

Figure 2.1.75 - EDS microanalysis for worn 232WC in the wear track area

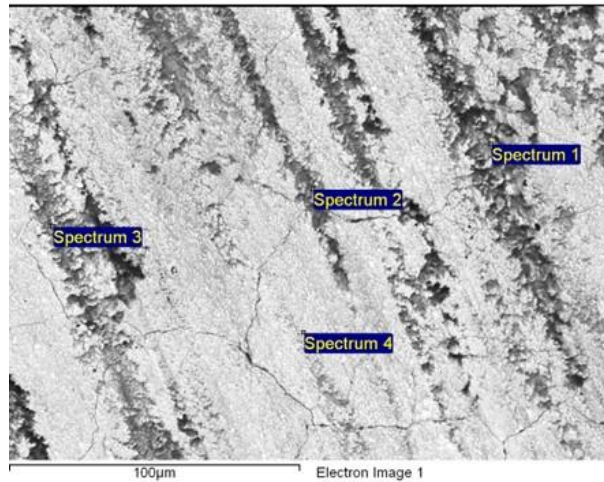
Spectrum	In stats.	O	Mg	Al	Cr	Fe	Co	W	Total
1	Yes	14.56	3.77	1.12	5.20		20.53	54.82	100.00
2	Yes	18.31	2.77		2.63	1.71	9.75	64.83	100.00
3	Yes	14.34	2.71	0.93	5.02		13.22	63.79	100.00
4	Yes	2.67			1.56		4.03	91.74	100.00

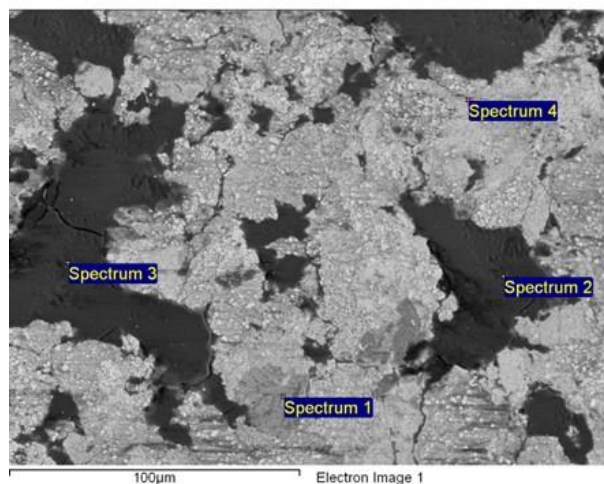
For 282WCr sample, EDS analysis reported below evidenced higher amount of iron (mixed oxides) in the wear track, if compared to 232WC, while outside the wear track no iron was found. Some zones with chromium oxide were identified (Figure 2.1.77 and Figure 2.1.78).

Spectrum	In stats.	O	Mg	Al	Cl	Ca	Cr	Fe	Ni	W	Total
1	Yes	2.07					51.55			46.38	100.00
2	Yes	32.87	6.13	2.09		0.85	29.12	10.74	8.02	10.18	100.00
3	Yes	35.72	6.96	2.12	0.57	0.99	26.83	9.75	8.89	8.15	100.00
4	Yes	6.03	0.65				20.77		11.07	61.49	100.00

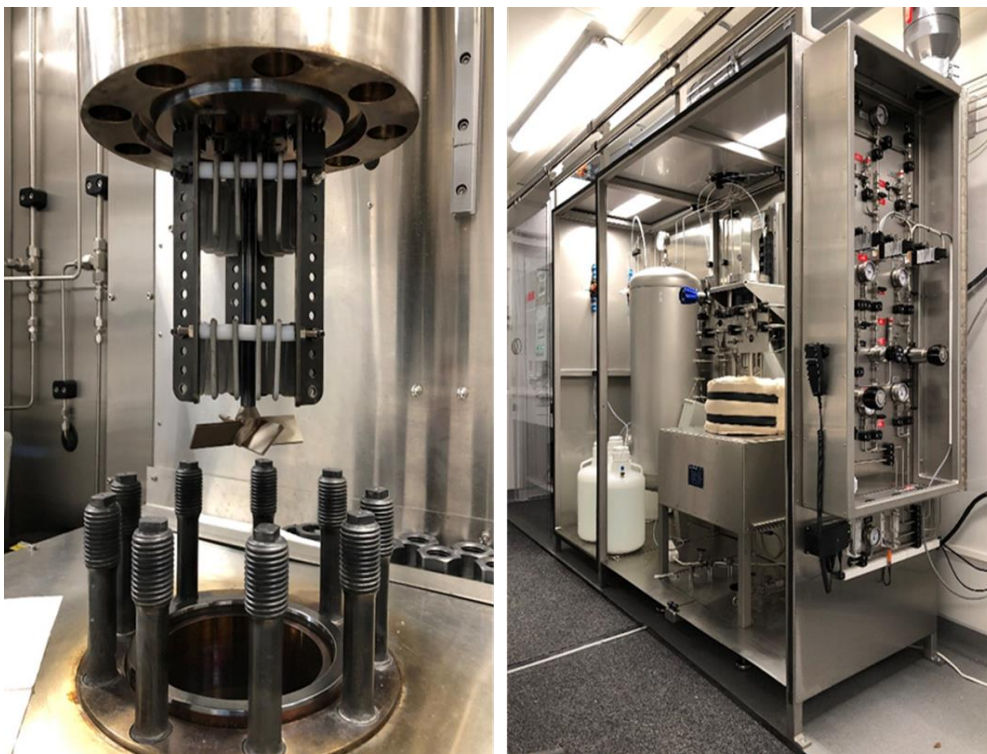
Figure 81 Design and setup of the high temperature and pressure corrosion testing facility at University of Iceland.
