Project acronym:	Geo-Drill		
Project title:	Development of novel and Cost-Effective drilling technology for geothermal Systems		
Activity:	LCE-07-17-Renewables		
Call:	H2020-LC-SC3-2018-RES-TwoStages		
Funding Scheme:	RIA	Grant Agreement No:	815319
WP 3	Material Testing and Characterization

D3.7 – Report on materials testing and characterization

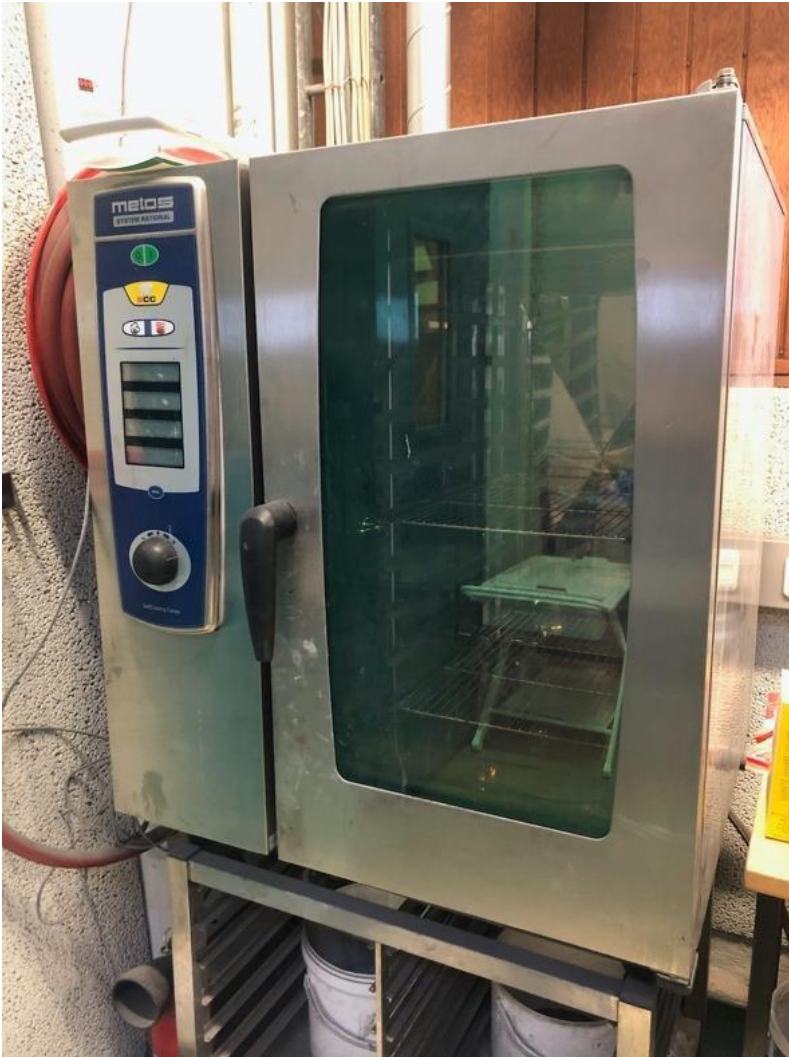
Figure 82 Oven used for lower T settings. Humidity level can be controlled.

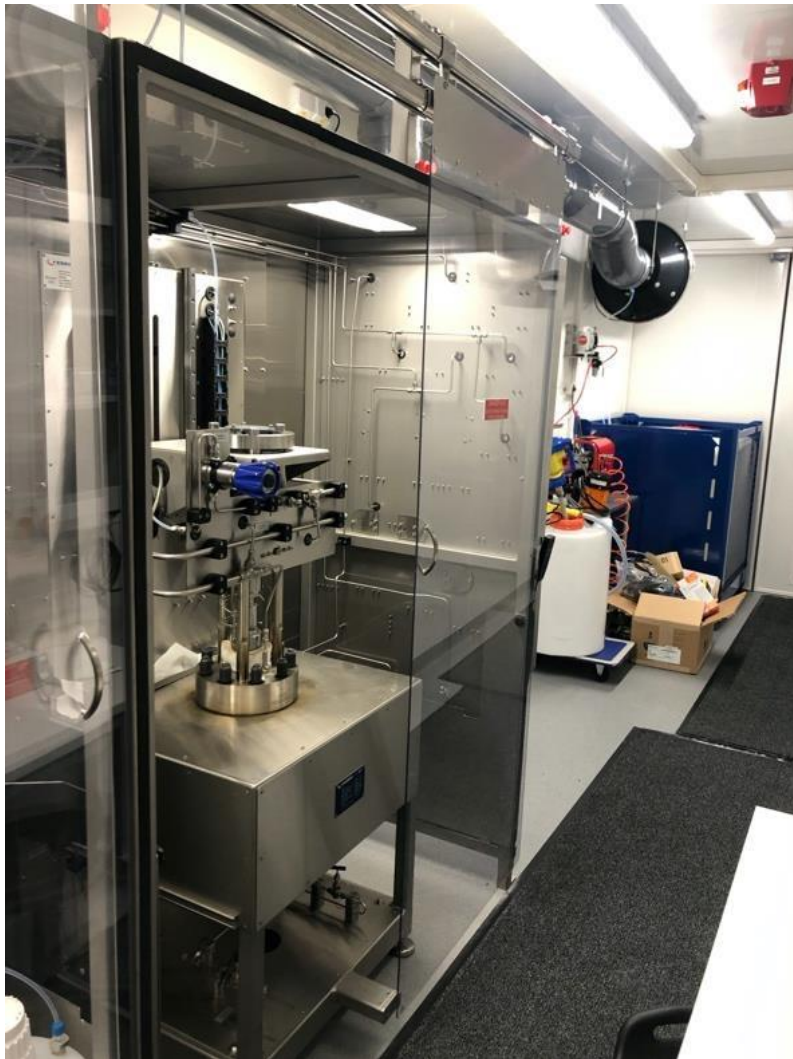
Figure 83 Autoclave setup used for simulating drilling environment.
