Project acronym:	Geo-Drill		
Project title:	Development of novel and Cost-Effective drilling technology for geothermal Systems		
Activity:	LCE-07-17-Renewables		
Call:	H2020-LC-SC3-2018-RES-TwoStages		
Funding Scheme:	RIA	Grant Agreement No:	815319
WP 3	Material Testing and Characterization

D3.3 - Report on erosion-corrosion testing of samples in simulated environment

Due date:	M23		
Actual Submission Date:	30/09/2021 (M29)		
Lead Beneficiary:	TWI		
Main authors/contributors:	TWI		
Dissemination Level¹:	PU		
Nature:	REPORT		
Status of this version:		Draft under Development	
		For Review by Coordinator	
		Submitted	
Version:	1.0		
Abstract	This deliverable describes work carried out on erosion-corrosion testing of WP2 developed coatings in simulated geothermal drilling environment.

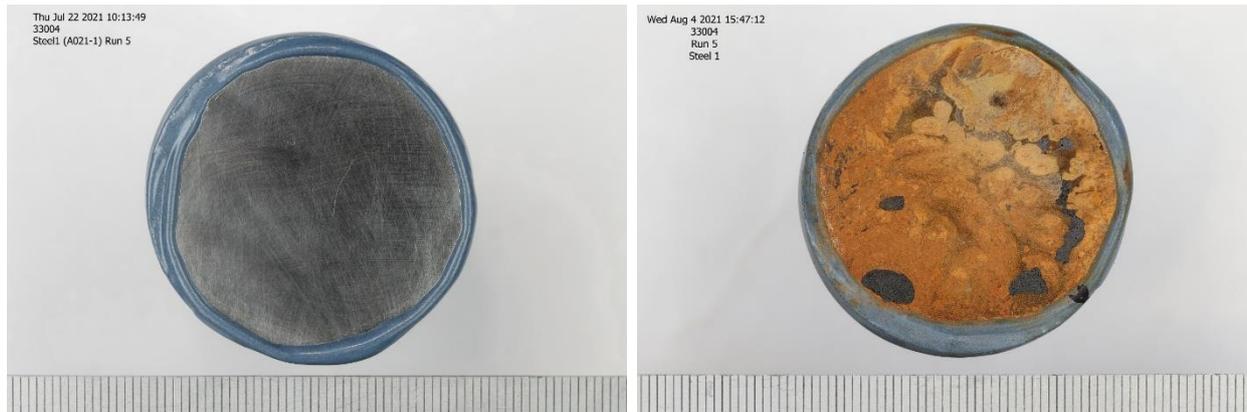
Figure 40 Digital images of Steel 1 after 7-day testing: (left) before testing, (right) after testing

After 7-day testing in simulated drilling environment, Steel 1 has a thick layer of corrosion product on its surface (Figure 40). SEM and EDX analyse confirms that its surface is mainly covered by iron oxide and some areas is covered with adhered substances from the simulated drilling fluid such as silicon oxide. Iron oxide layer formed due to corrosion has a very porous top surface and no sign of scratch from erosion on the surface is observed (Figure 46). This possibly indicates that corrosion takes more predominant role in the selected erosion-corrosion testing condition for Steel 1 and formation of corrosion product is faster than generation of scratch if any. SEM and EDX analyse on its cross-sectioned surface indicates that the formed corrosion layer is about 15µm thick (Figure 52). Though the corrosion layer formed during the 7-day testing is of similar thickness as when compared with the one being tested under 24h, it is much denser (Figure 15). From its corrosion rate measurement, Steel 1 has increased corrosion rate up to about 1.00mm/year at the first 5h and then gradually decreases and becomes stabilised (Figure 58).

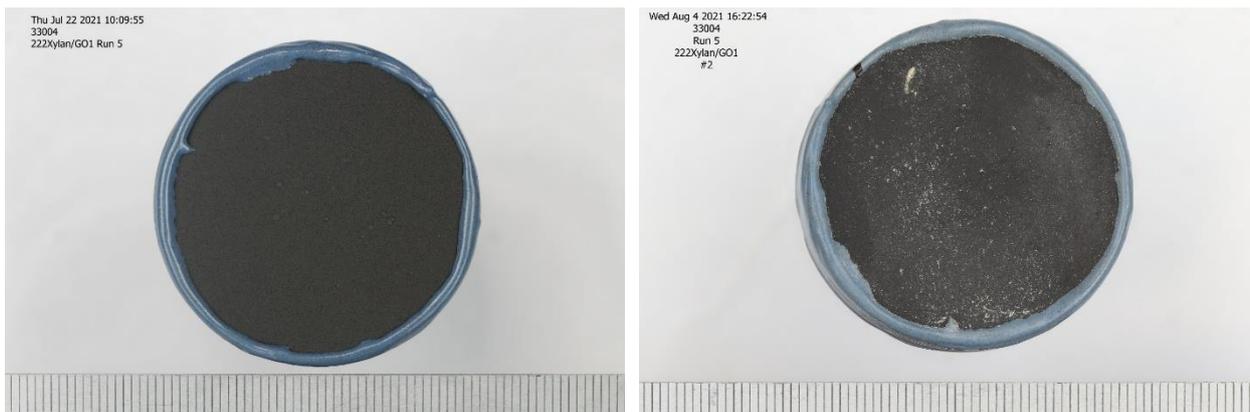
Figure 41 Digital images of 222Xylan/GO after 7-day testing: (left) before testing, (right) after testing

After 7-day testing in simulated drilling environment, there is no any obvious damage can be observed on the surface of sample 222Xylan/GO1 (Figure 41). SEM and EDX analyse on its top surface presents some very fine adhered sand particles that are uniformly distributed across its surface, but there is no sign of corrosion product or any scratch from erosion-corrosion can be observed (Figure 47). From SEM and EDX analyse on its cross-sectioned surface, some alumina oxide grits indicated the surface was previously grit-blasted for improved adhesion strength of the coating but no sign of formation of iron oxide can be found (Figure 53). Though corrosion rate for this sample may not be accurate due to its non-conductivity, above analyse results can prove

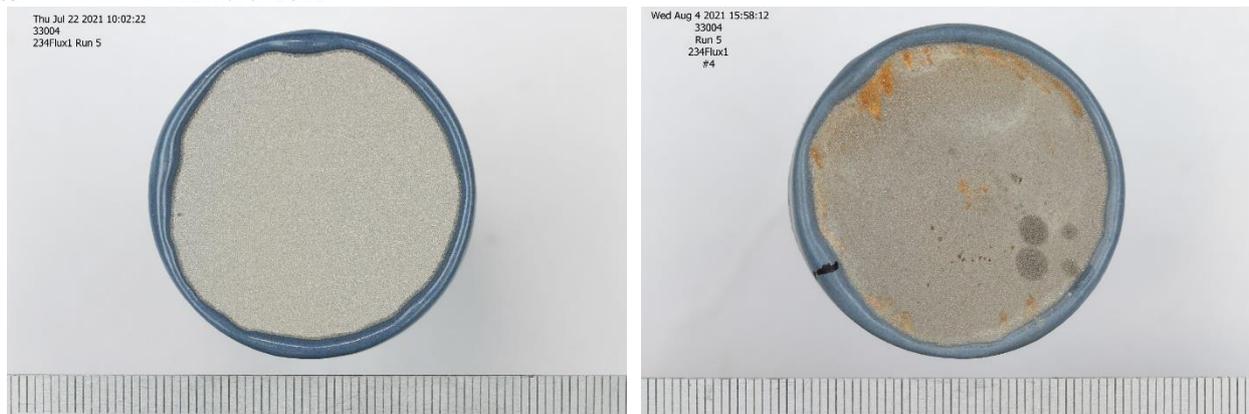
Figure 43 Digital images of 234Flux1 after 7-day testing: (left) before testing, (right) after testing

After 7-day testing in simulated drilling environment, self-fluxing Ni alloy coating (234Flux1) seems to protect the substrate well with only little corrosion product can be seen on its surface (Figure 43). SEM and EDX analyse on the top surface shows that some adhered liquid substances such as sand was scattered across the sample surface, but no sign of scratch from erosion can be found (Figure 49). Further examination on its polished cross-sectioned surface indicates that some iron oxide was formed at the coating top surface during testing but no corrosion product is found in the coating (Figure 55). EDX analyse at the coating-substrate interface shows a strong peak for oxygen, indicating that corrosive liquid had penetrated onto the substrate and some corrosion reaction at the interface had happened. However, the coating integrity still seems good (Figure 55). Corrosion rate measurement shows that sample 234Flux1 was quite stable during the 7 days and its value is always lower than Steel 1. Therefore, the selected self-fluxing Ni alloy coating could provide effective protection on Steel 1 in simulated drilling environment. But attention should be paid if it is used for longer-term protect in its as-deposited condition.

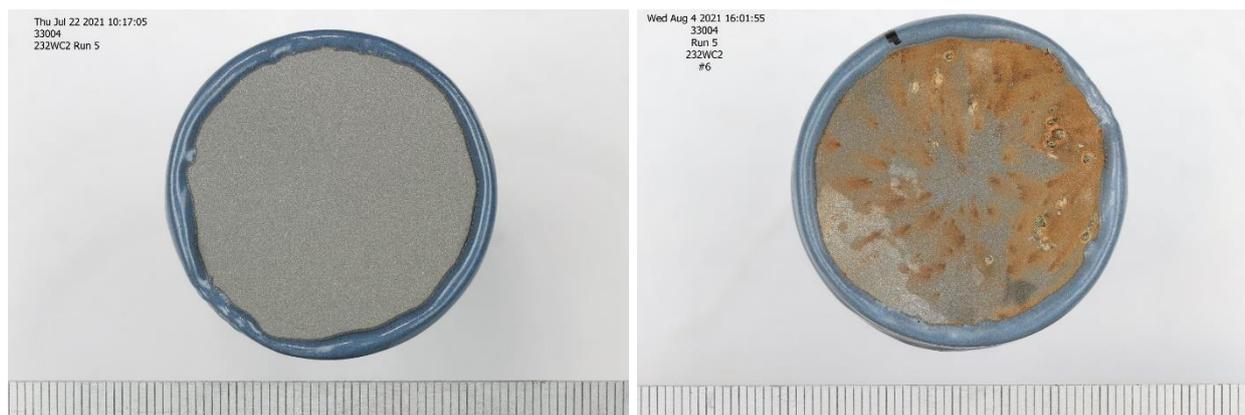
Figure 45 Digital images of 232WC2 after 7-day testing: (left) before testing, (right) after testing

After 7-day testing in simulated drilling environment, some corrosion product was formed on its surface (Figure 45). SEM and EDX analyse on its top surface and cross-sectioned surface shows that iron oxide was found both
